NAVAL AIR STATION  
ALAMEDA, CALIFORNIA  
FPO-1-82(20)

**UNDERWATER FACILITIES  
INSPECTIONS  
AND  
ASSESSMENTS  
AT**

**NAVAL AIR STATION  
ALAMEDA, CALIFORNIA**

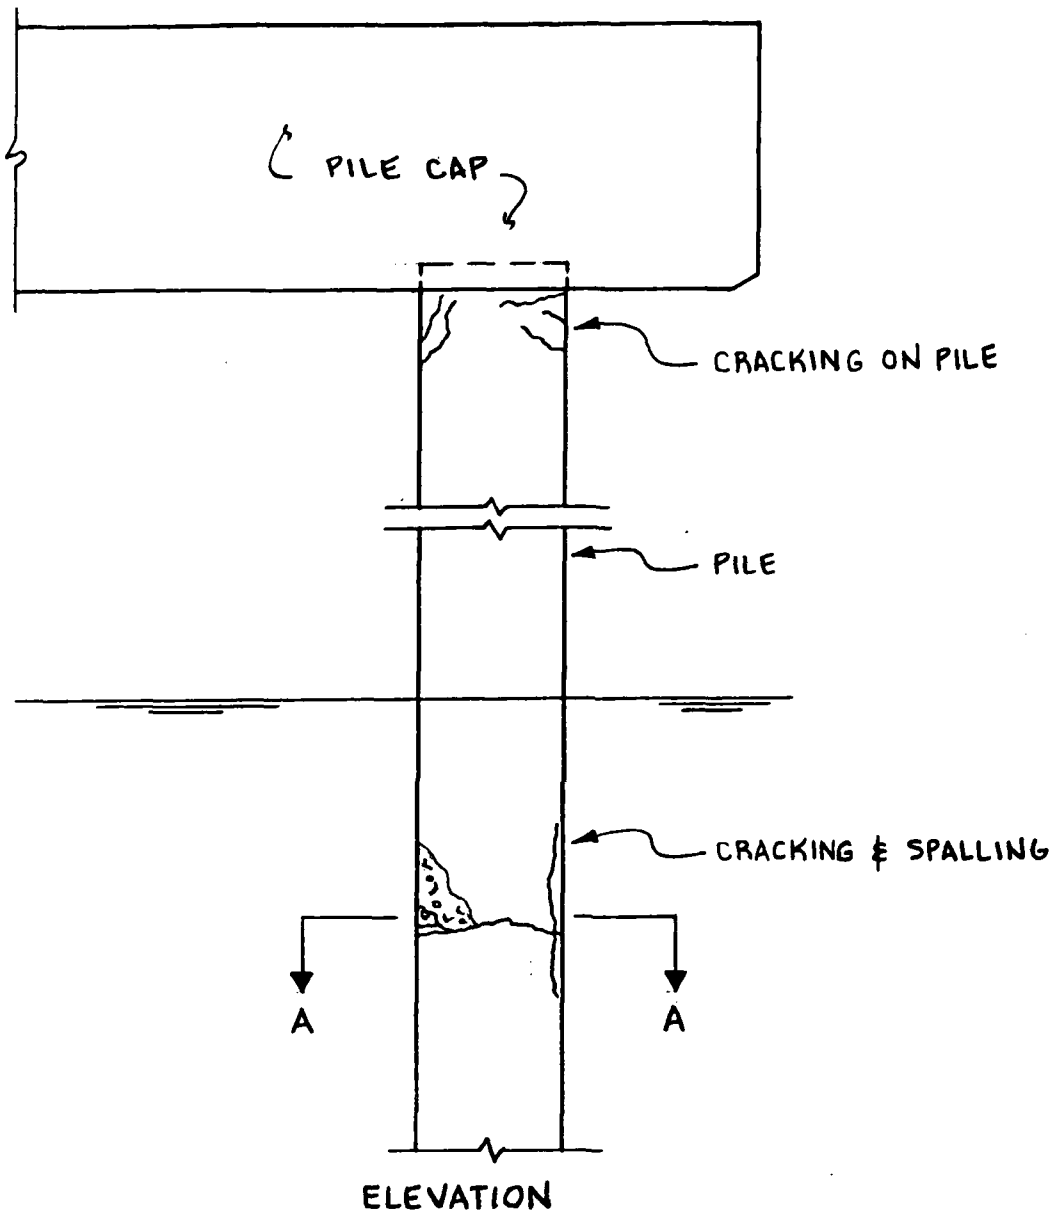
4

On the concrete piles, deterioration was noted with respect to its structural significance. Piles not capable of supporting the imposed load were noted as severely damaged. This anomaly displayed the following characteristic:

- o Piles cracked and broken with rebar still intact  
(see Figure 4).

SEVERE DAMAGE

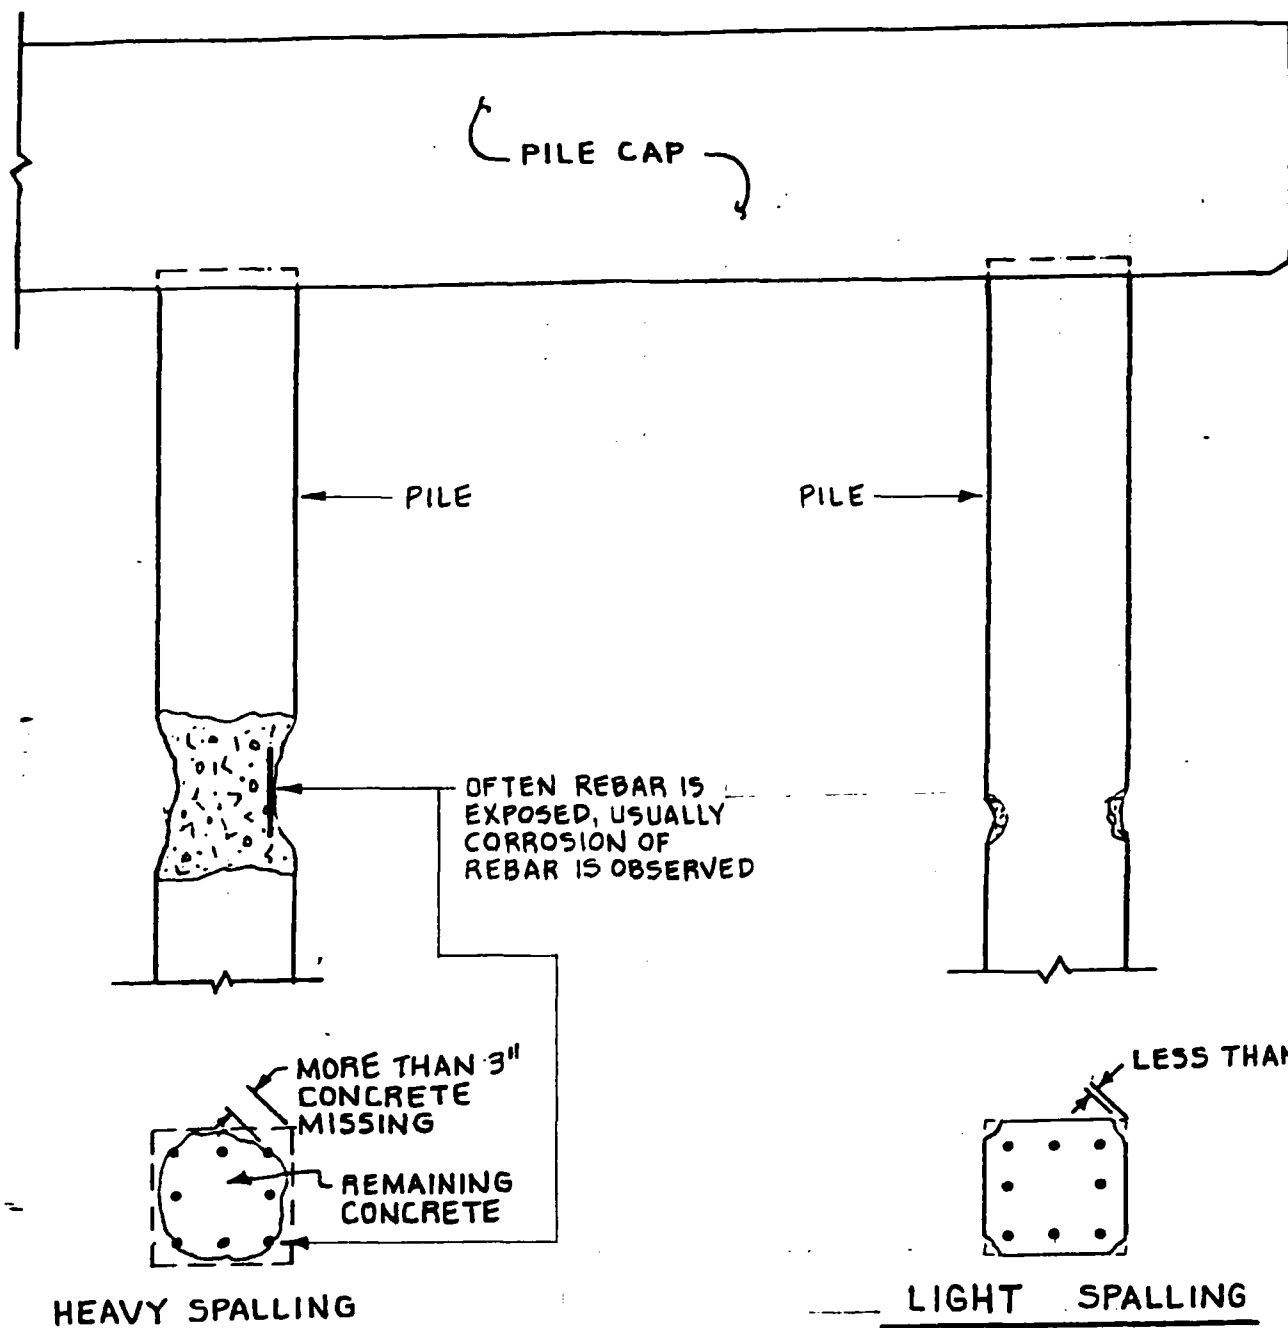
GRAPHIC SCALE	CHILDS ENGINEERING CORPORATION BOX 333 MEDFIELD, MA	CHESAPEAKE DIVISION NAVAL FACILITIES ENGINEERING COMMAND WASHINGTON, D.C.	
NA		NAVAL AIR STATION ALAMEDA, CA	FIG. NO. 5
		PILE CONDITION

A condition where the concrete has spalled to a point where the cross sectional area of the remaining pile has marginal capabilities to support its designed load is noted as heavy spalling (see Figure 5). In many cases of heavy spalling, rebar is exposed to the water and has experienced corrosion.

Spalling that does not immediately threaten the structural integrity of the pile was noted as light (see Figure 5).
